***DOE/ID-10918  
February 2002***

***Site 015 Track 1 Decision Documentation  
Package, OU 10-08***

**Site Description:** Navy Debris in Canal Between TRA and NRF

**Site ID:** 015

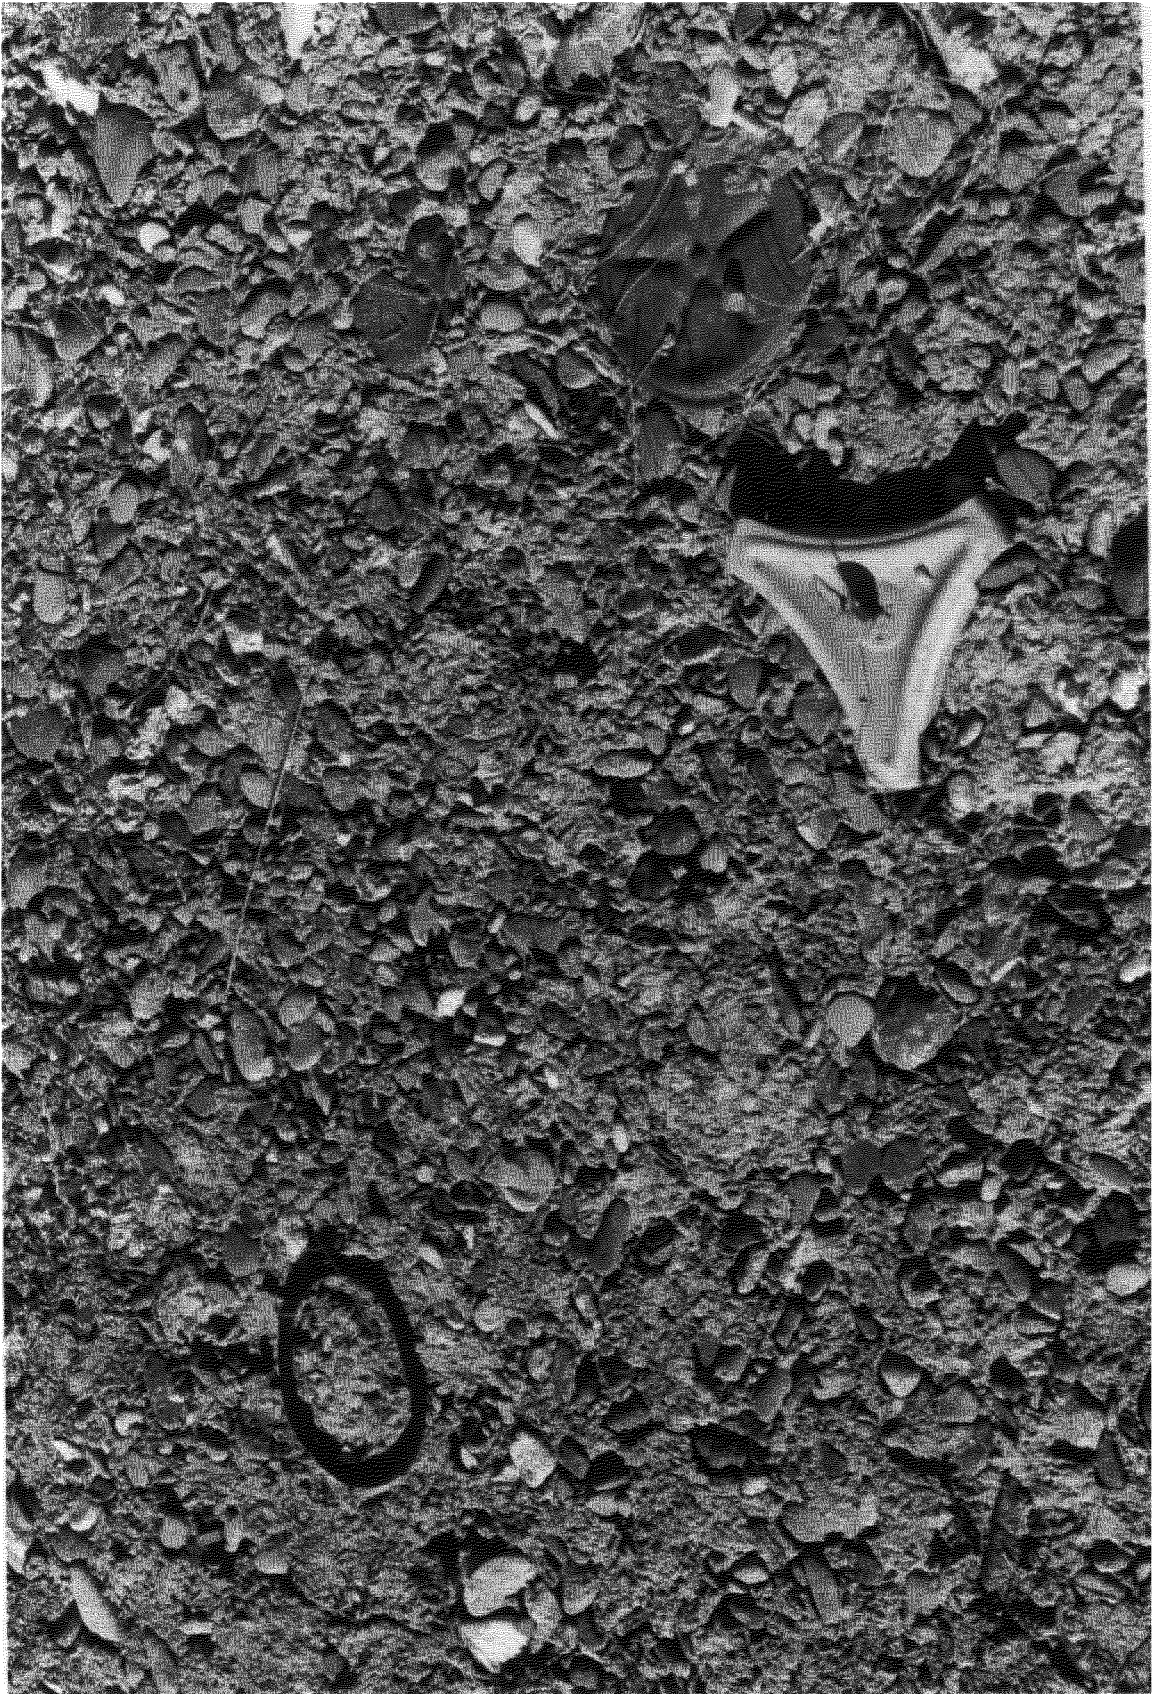
Site 015 consists of scattered surface debris located .25 miles inside a large canal starting at the intersection of roads T3 and T14 off Lincoln Boulevard proceeding north. The closest INEEL facility is the Naval Reactor Facility, located approximately 2-1/2 miles northeast. Surface debris consists of weathered triangular and round metal objects and rubber rings.

Site: 015, Navy Debris in Canal Between TRA and NRF  
(99-465-1-21)

It is recommended that this newly identified site be classified as No Further Action. Field investigations, interviews, historical knowledge of this area, and photographs indicate it highly unlikely that hazardous or radioactive materials were generated or disposed of at this site. It is located in a remote, abandoned area with no viable pathways or receptors. The NRF is the closest facility located approximately 2-1/2 miles north. There is nothing present at this site that would indicate evidence of contaminant migration, or historical or threatened release of hazardous substances, pollutants or contaminants, and, as such poses no potential risk to human health or the environment.

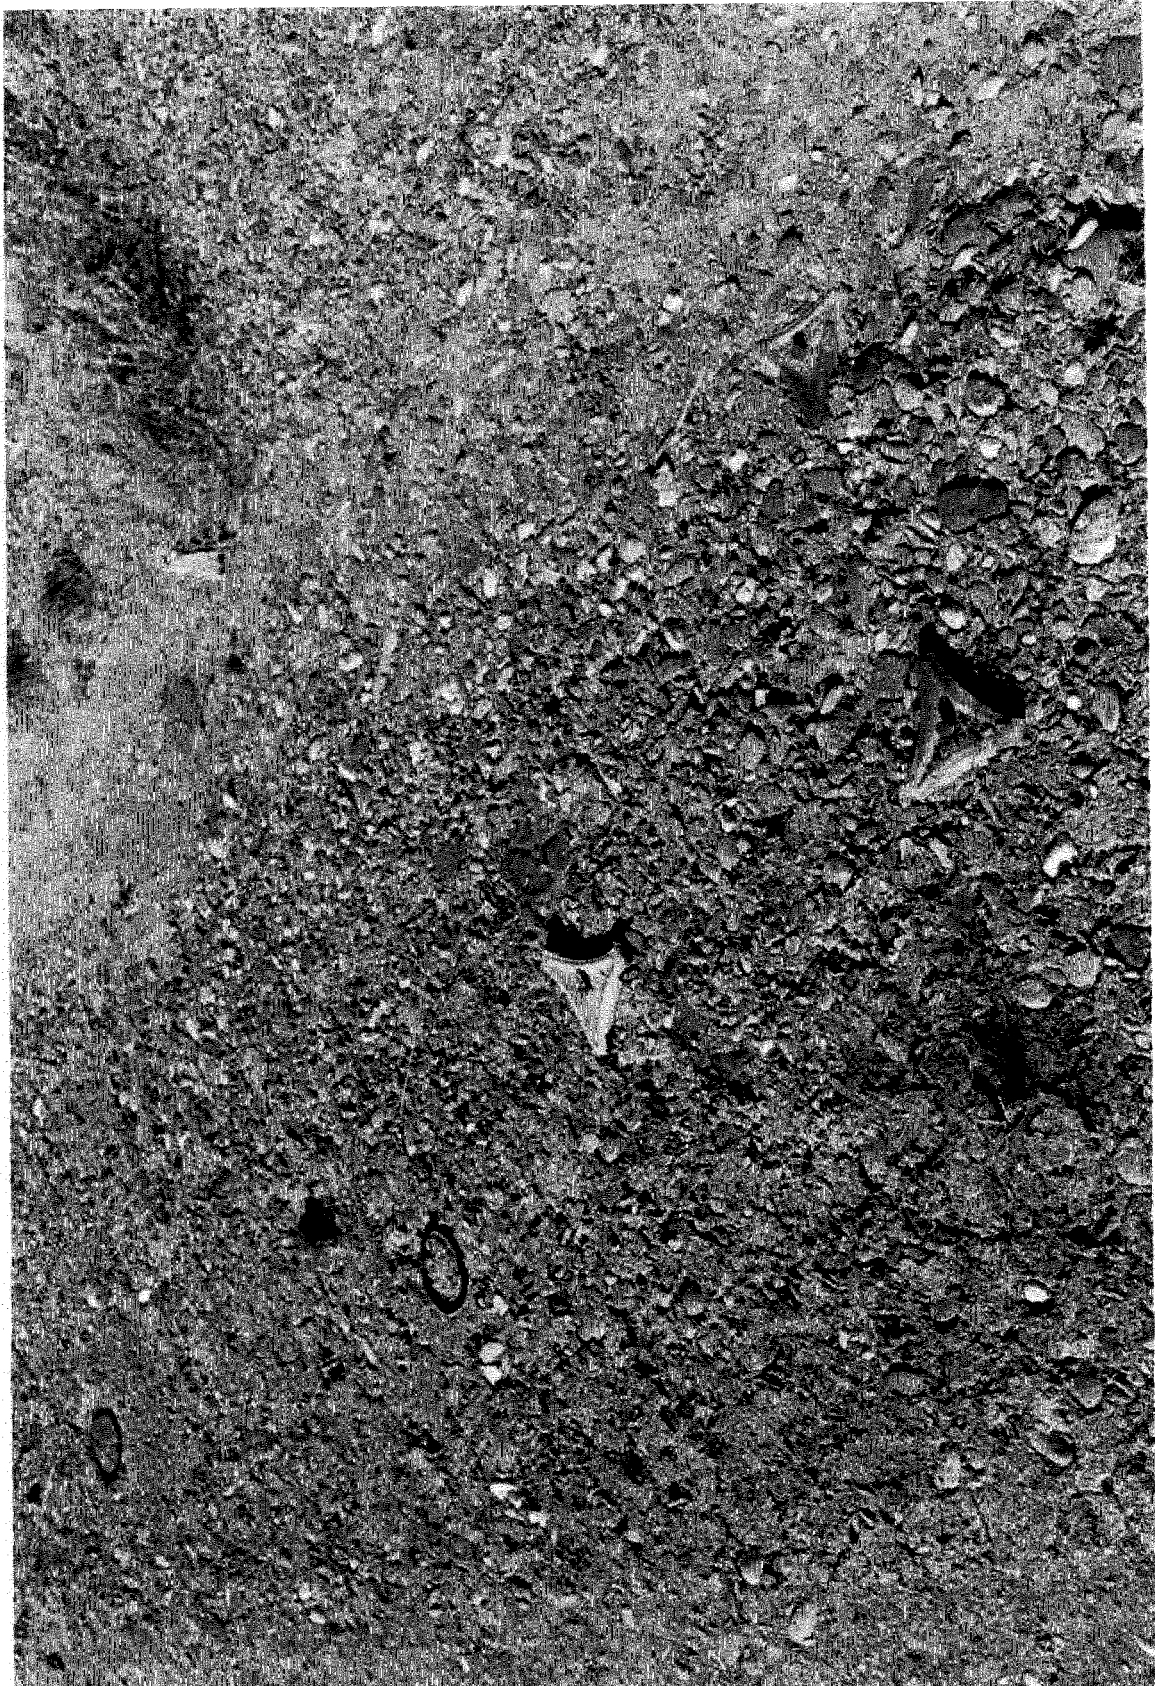
Site: 015, Navy Debris in Canal Between TRA and NRF  
(99-465-1-22)
